**Subject: Carleton Condominium Corporation No. 383 – 2759 Carousel Crescent, Ottawa  
Garbage Room Repairs  
Completion Review Letter and Certificate of Substantial Performance**

## COMPLETION SITE REVIEW

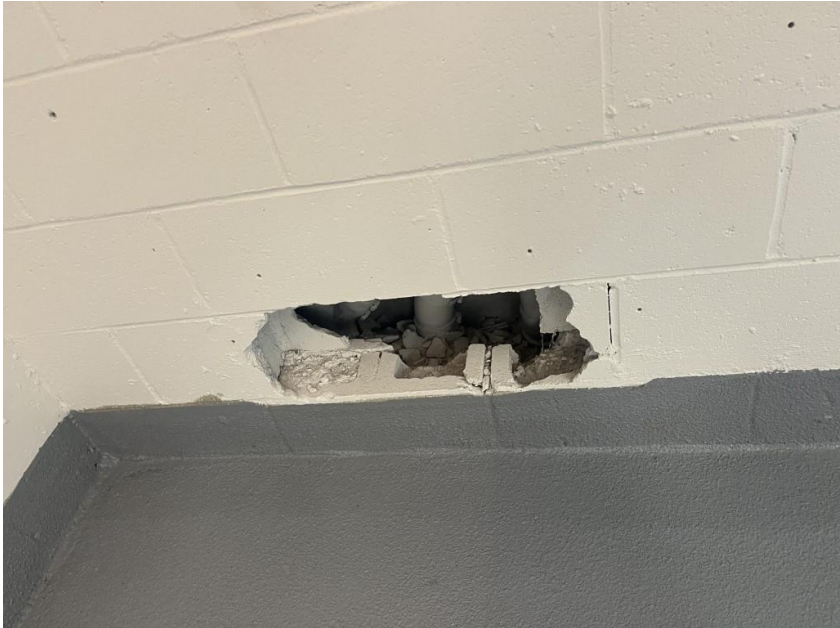
- **Wall Vent:** Fully reinstate wall grille located on the south wall, removed during the work (refer to Photo 1).  
*Post Visit Note: We understand that the wall grille was reinstated same day.*
- **Compactor Electrical Coordination:** Coordinate with electrical subcontractor for the reconnection of the new compactor.  
*Post Visit Note: This scope was subsequently removed at the request of the Board. Electrical coordination will be performed by the Corporation.*

| Photo | Description |
|---|---|
| | <p><b>Photo 1:</b></p> <p>Opening at South Wall.</p> |

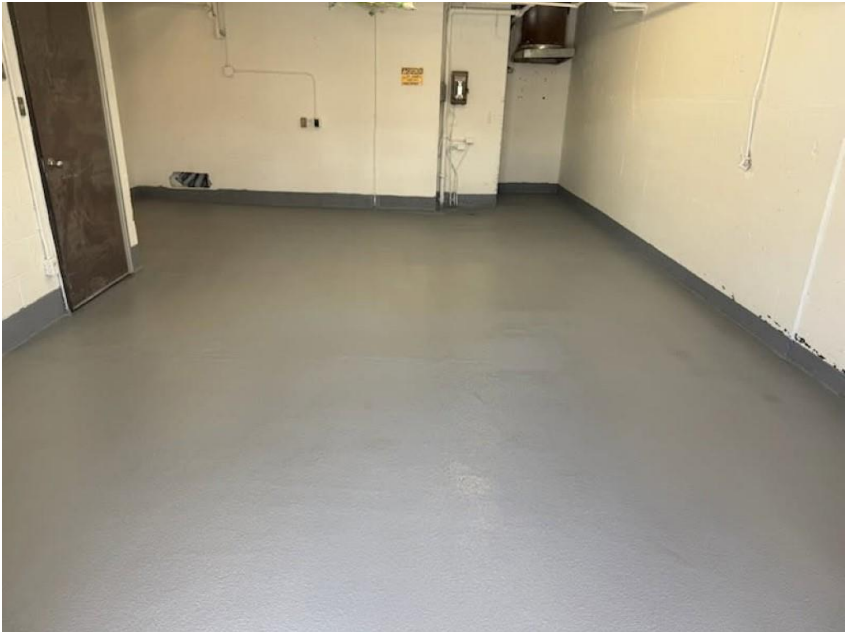
| Photo | Description |
|---|---|
| | <p><b>Photo 2:</b></p> <p>Overview of the Waterproofing Membrane installation.</p> |

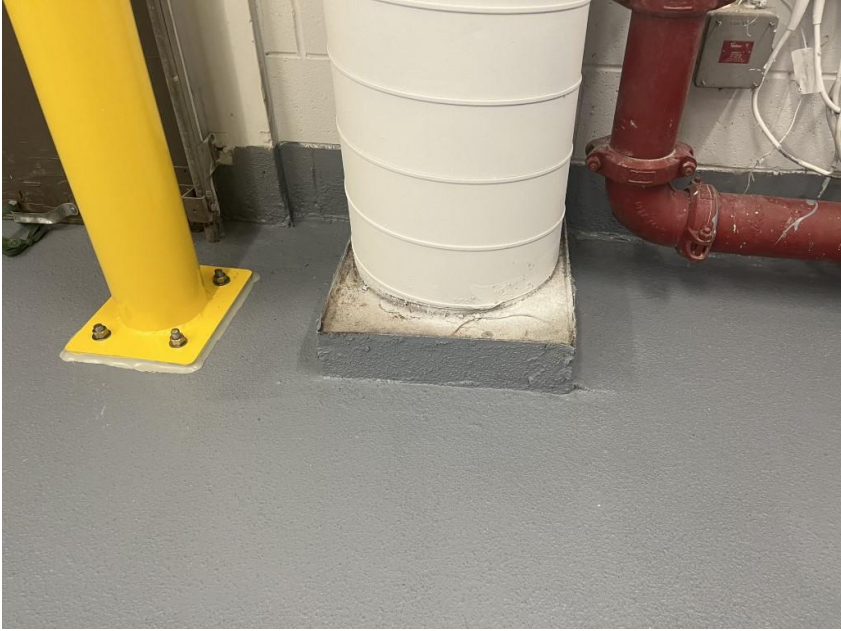
| Photo | Description |
|---|---|
| <p>A photograph showing a yellow bollard on the left, a large white cylindrical duct in the center, and a red fire pipe on the right. The floor is a smooth, grey material. The base of the duct and bollard shows some detailing work.</p> | <p><b>Photo 3:</b></p> <p>General view of the detailing work at duct and replaced bollard.</p> |

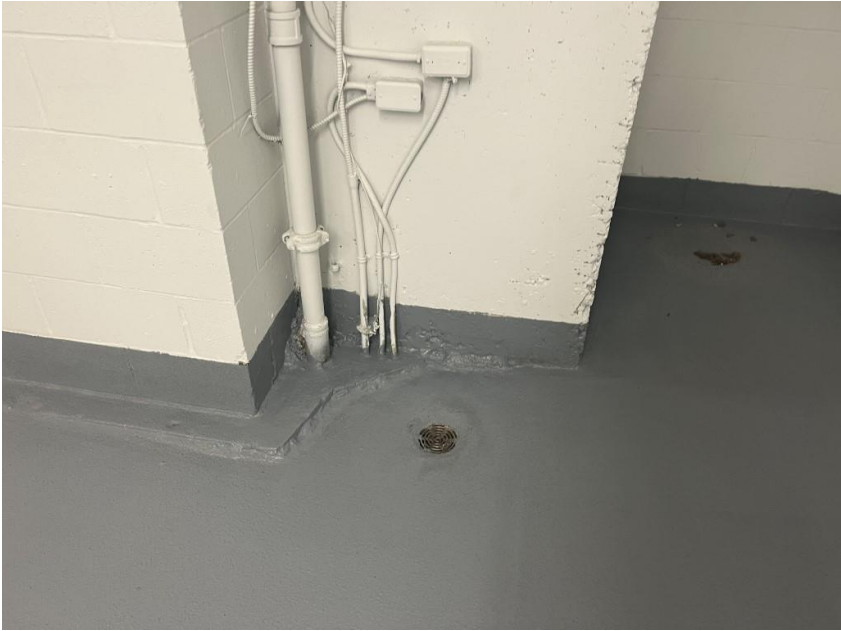
| Photo | Description |
|---|---|
| <p>A photograph showing a corner of a room with a grey floor and white walls. A white pipe and some electrical conduits run down the wall. A drain is visible in the floor near the wall. The area around the drain shows detailing work.</p> | <p><b>Photo 4:</b></p> <p>General view of the detailing work around drain.</p> |
